## MS355 Overview and Specifications

The MS355 is a multi-gigabit switch line designed to help prepare Organizations for the increased bandwidth requirements of the upcoming 802.11ax wireless standard with high-count mGig switch ports and increased switching capacity to meet the demands of next generation access points. Networks with sizeable wireless deployments such as universities, hospitals, and large public complexes like transportation centers can all benefit from the increased bandwidth capabilities of the MS355.

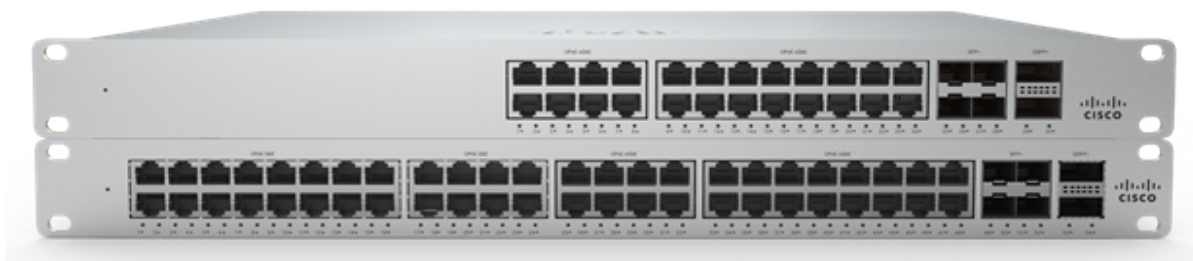
With 4 different models, each with multiple mGig RJ45 ports capable of negotiating up to 10Gbps, 40G QSFP+ ports, and dedicated 100G hardware stacking ports, the MS355 line is fully ready to support the future deployment of 802.11ax wireless infrastructure across a variety of different environments.
